Mr. Chris Miller  
**City of Adrian**  
135 East Maumee Street  
Adrian, Michigan 49221*RE: Asbestos Sampling of Debris Piles, 1365 Beecher Street, Adrian, Michigan  
(ASTI Project No. 9408)*

Former Dura Site, 1365 East Beecher Street, Adrian, Michigan

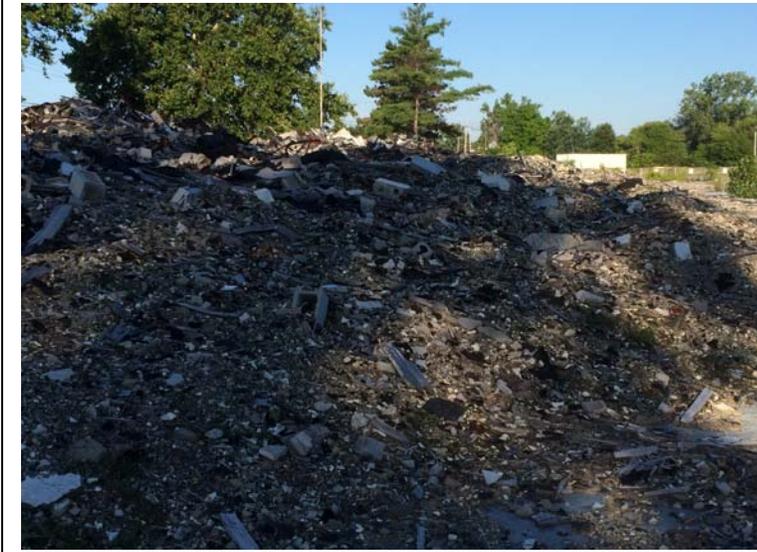
**Photo 1.** General view of stockpiled debris located on the south portion of the Property

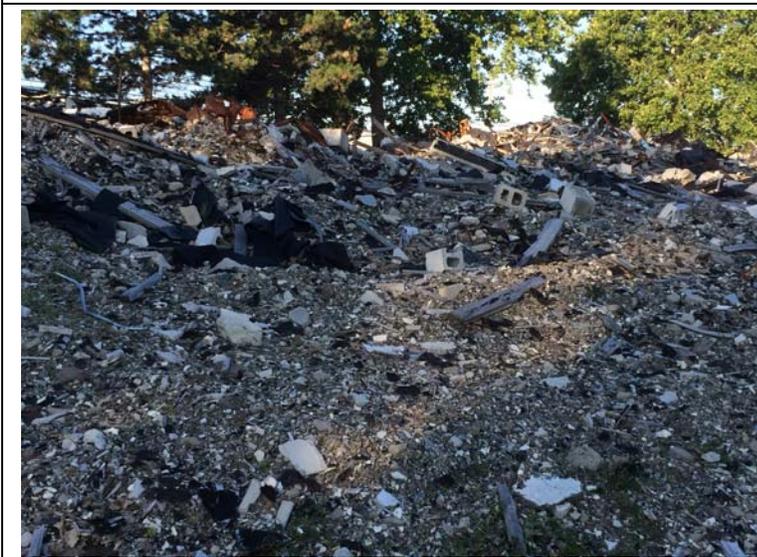
**Photo 2.** General view of stockpiled debris located on the south portion of the Property

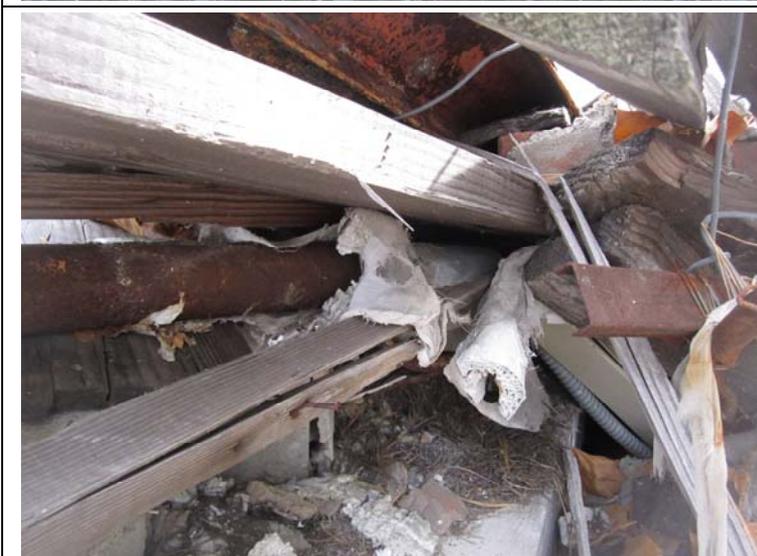
**Photo 3.** Close-up view of stockpiled debris on south portion of Property. Note pipe insulation in central portion of photograph.

Review of the asbestos sample results revealed the identification of asbestos in each of the three debris piles. Accordingly, ASTI recommends that the debris be handled as friable asbestos-contaminated waste and care should be rendered to minimize disturbance of the material and the resulting potential release of asbestos fibers, including controlling fugitive dust. According to classification guidelines set forth in NESHAP, the pipe insulation and surfacing material are regulated materials, therefore these materials must be addressed by a licensed abatement contractor using Class I removal techniques and engineering controls to control dust.

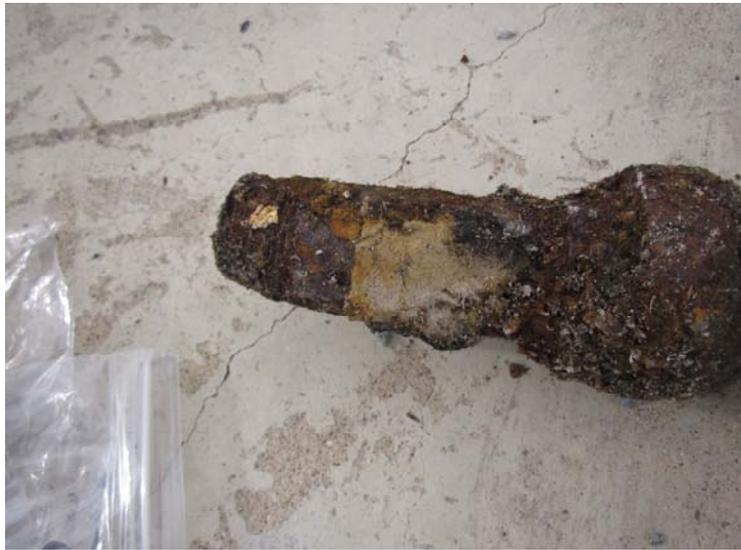
**Photo 4.** General view of pipe wrap on original pipe collected from southern debris pile.

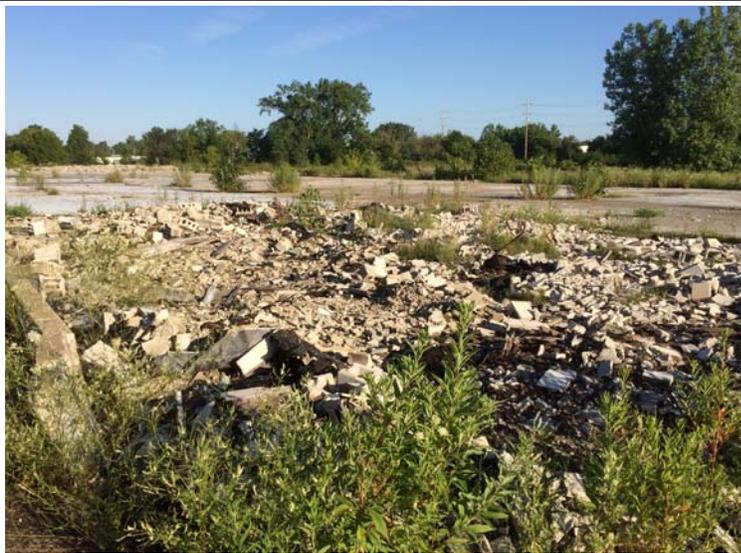
**Photo 5.** General view of stockpiled debris located on the western portion of the Property

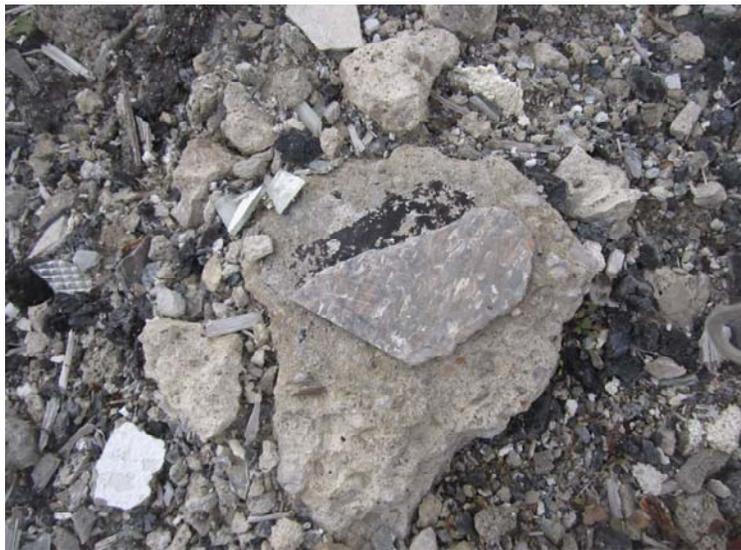
**Photo 6.** General view of floor tile material and mastic observed in western debris pile

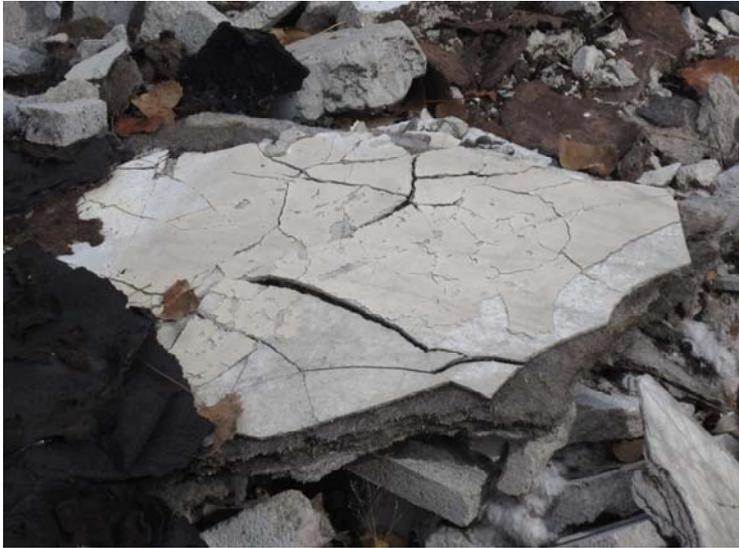
**Photo 7.** General view of surfacing material found in western debris pile

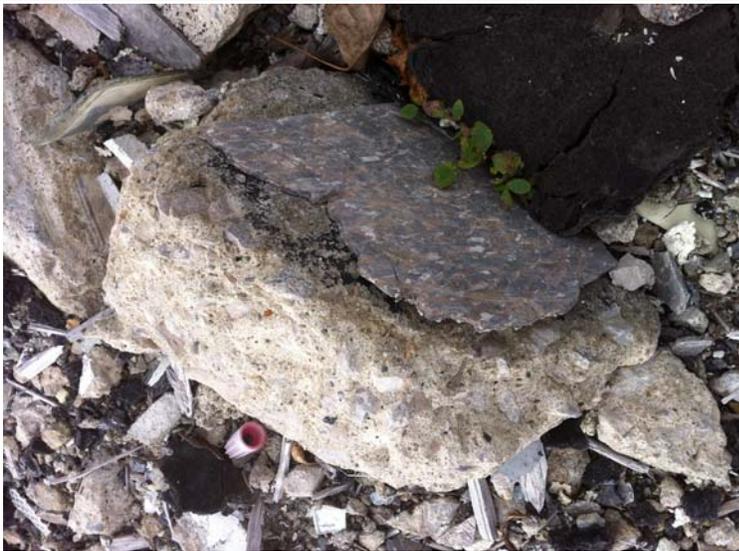
**Photo 8.** General view of floor tile in western debris pile
